DEPARTMENT OF TRANSPORTATION**DIVISION OF ENGINEERING SERVICES**

Contract #: 04-0120F4Cty: SF/ALA Rte: 80 PM: 13.2/13.9File #: 69.28**WELDING INSPECTION REPORT****Resident Engineer:**Pursell, Gary**Address:** 333 Burma Road**City:** Oakland, CA 94607**Report No:** WIR-001759**Date Inspected:** 12-Mar-2008**Project Name:** SAS Superstructure**OSM Arrival Time:** 600**Prime Contractor:** American Bridge/Fluor Enterprises, a JV**OSM Departure Time:** 1730**Contractor:** Zhenhua Port Machinery Company, Ltd (ZPMC), Changxing Island **Location:** Shanghai, China

Bridge No: 34-0006**Component:** Tower & OBG**Summary of Items Observed:**

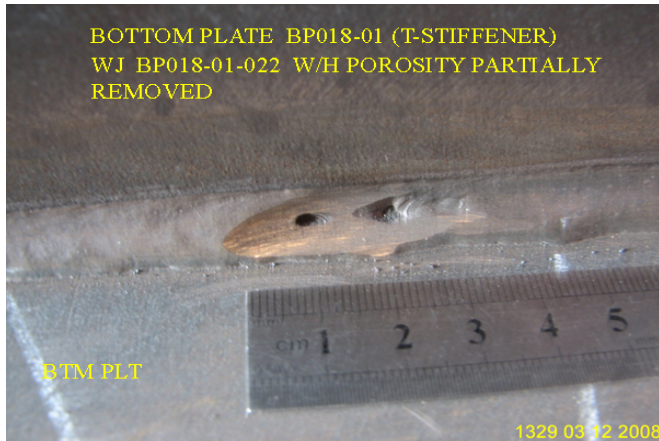
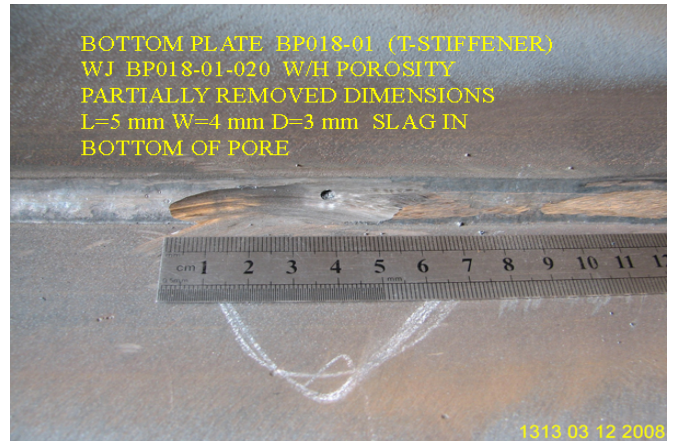
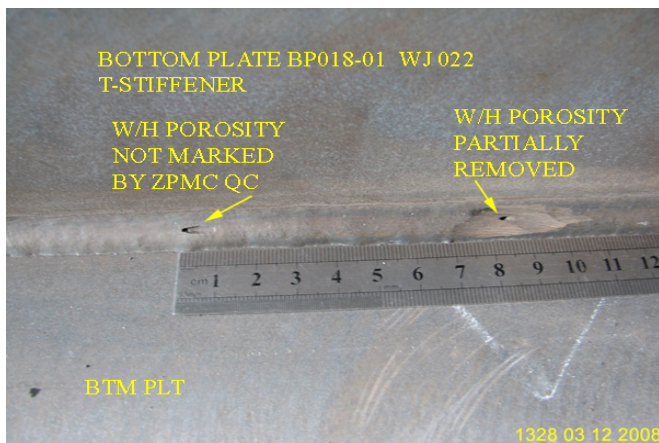
The QA Inspector randomly observed several areas in the fillet welds attaching T-Stiffeners to Bottom Plate BP018-01, which had been excavated to remove weld discontinuities. These areas had been marked up by ZPMC QC prior to the excavating. The QA Inspector randomly observed that the indications still remained in these areas even after removing the weld metal flush with the base metal of the T-Stiffeners webs. The QA Inspector also randomly observed an area of worm hole porosity that had not been marked by ZPMC QC, adjacent to areas that had been marked and excavated. The attached photographs provide additional detail.
